2 . Permanent Ground Displacements in Noshiro City during The 1983 Nihonkai-Chubu Earthquake

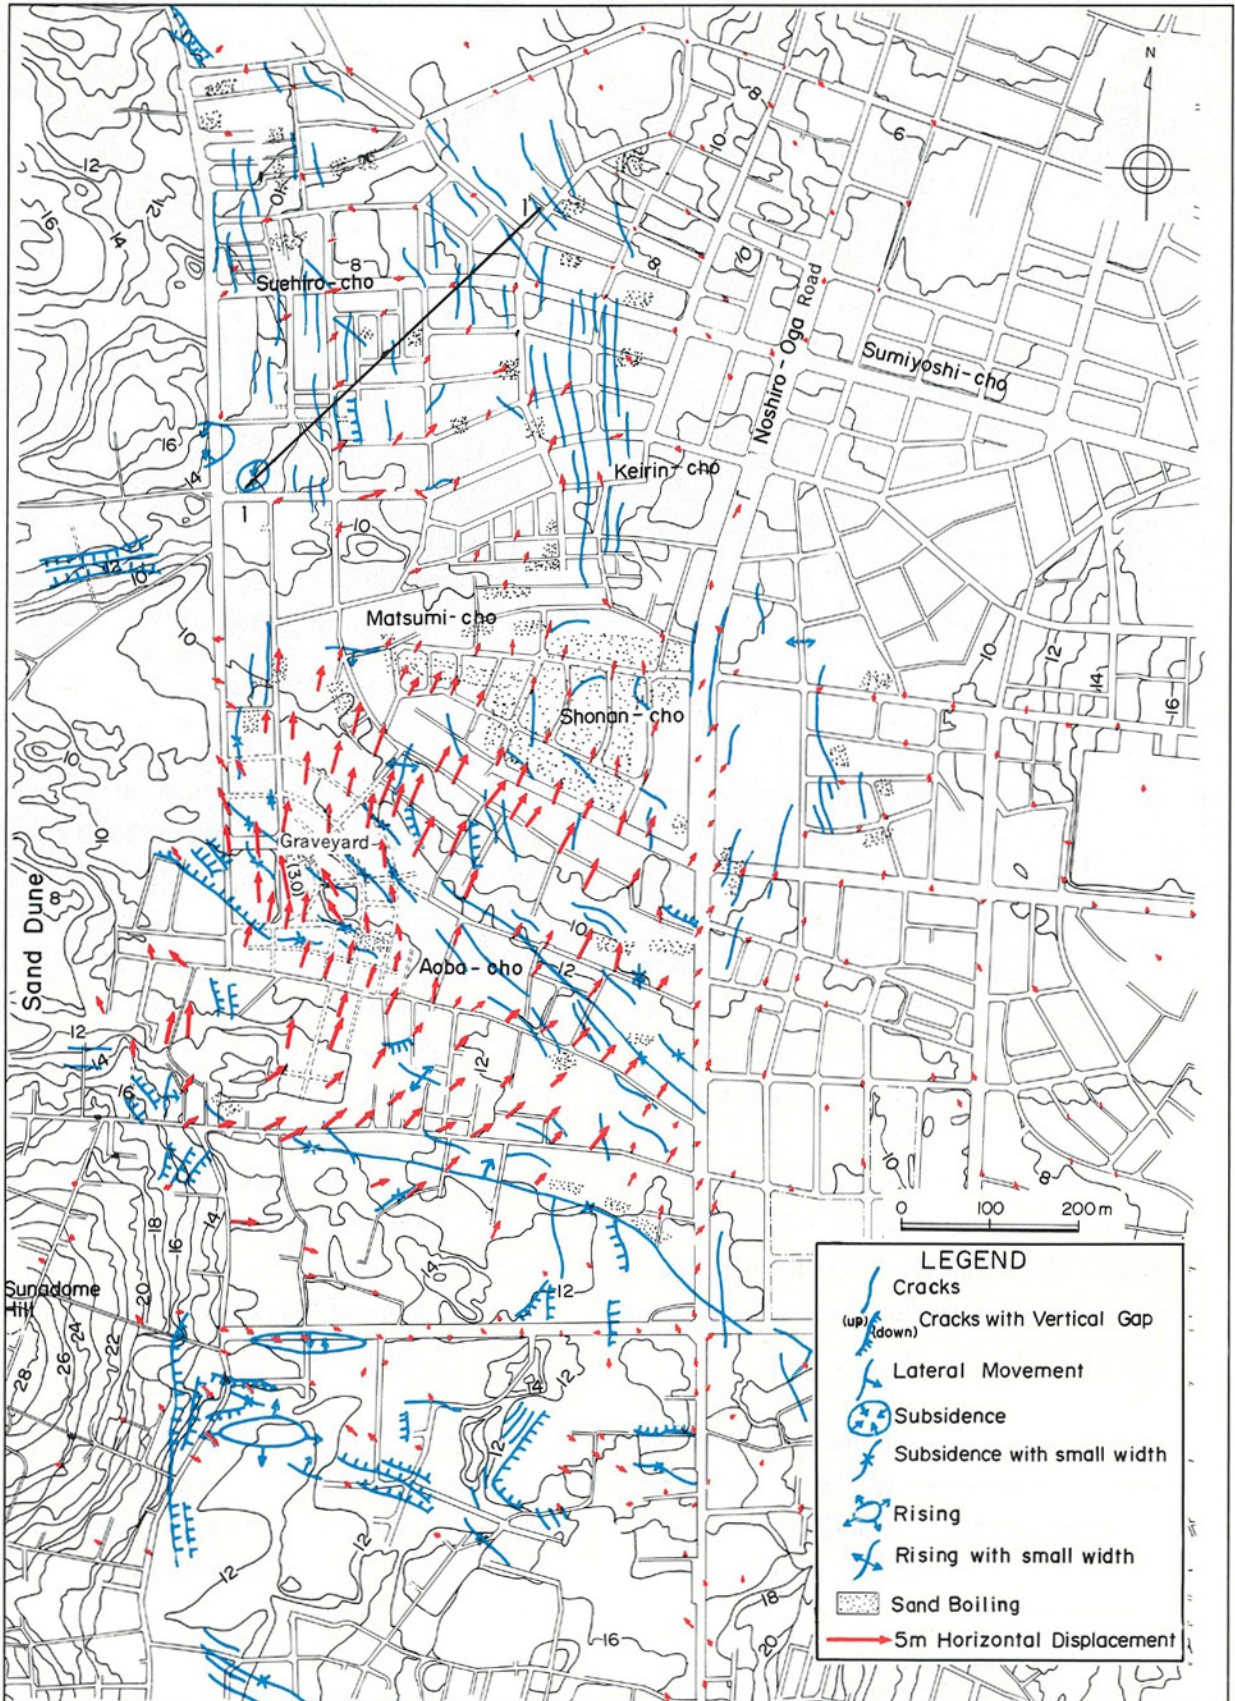
Fig. 2-3 Permanent horizontal ground displacements in the northern part of Noshiro City

In the northern area, as shown in Figure 2-3, permanent ground displacements were dominant in the western half on the west side of the Noshiro-Oga Road, which is gently sloped, and forms the transition area between the sand dunes and the alluvial plane. The displacements started from halfway down the sand dune, Sunadome Hill, and extended for about 1 km in a northerly or northeasterly direction. The maximum horizontal displacement in the northern area reached about 3 m, on the slopes of Aoba-cho.

On the other hand, the permanent ground displacements in the eastern half on the east side of the Noshiro-Oga Road, which is located mostly on the alluvial plane, were very small, at less than 1.0 m.

Figures 2-3 and 2-4 also show ground failures such as sand volcanoes, cracks, subsidences and bulgings, as investigated by the University of Akita.⁽³⁾ In the northern area, as shown in Figure 2-3, the ground failures were concentrated in the western part (Aobao-cho, Matsumi-cho, etc.), where the permanent ground displacements were large.

On the eastern side of the Noshiro-Oga Road, where the permanent ground displacements were very small, very few ground failures were found. From the figures, it can be seen that the horizontal directions of the permanent ground displacements are mostly perpendicular to those of the ground cracks.

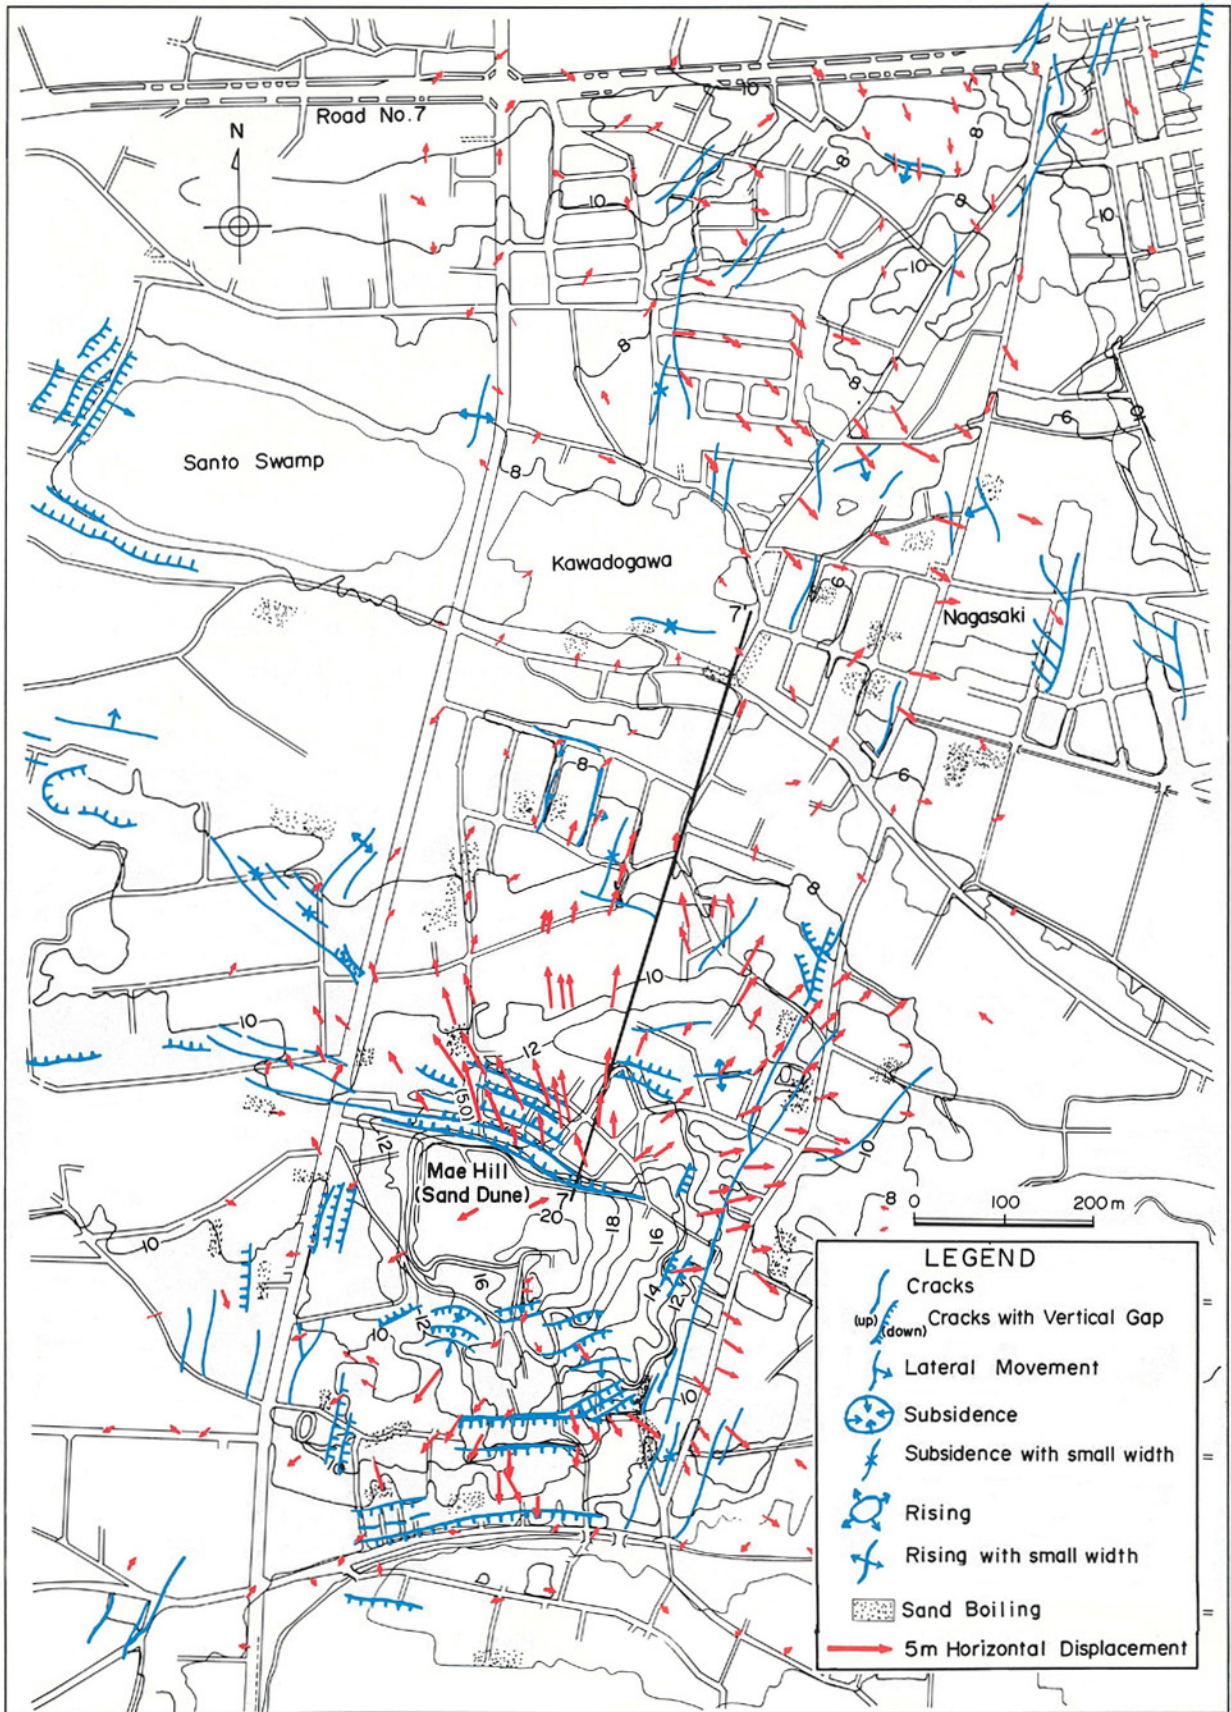
Fig. 2-4 Permanent horizontal ground displacements in the southern part of Noshiro City

In the southern area, as shown in Figure 2-4, a large displacement occurred on the slope of Mae Hill, a sand dune about 10 m higher than the surrounding area. On the northern slope of the hill, the displacements started from near the top and extended horizontally for more than 400 m in a northerly direction. The maximum horizontal displacement exceeded 5.0 m and the direction of the displacement was almost parallel to that of the slope.

The displacements on the southern slope of Mae Hill extended horizontally for about 300 m from the top to near the road running east-west at the toe of the slope. The displacements on the eastern slope also extended to near the north-south road, where the ground surface was mostly flat.

In addition to the displacements around Mae Hill, another slide was found in the southern part, commencing near Road No. 7 in the southeasterly direction and extending for about 300 m distance.

In the southern part, as shown in Figure 2-4, large cracks and subsidences were found around Mae Hill, where displacements exceeding 5.0 m occurred. Details of the permanent ground displacements and ground failures on the northern slope of the hill are shown in Figure 2-6. The region shown in Figure 2-6 corresponds to Photo 2-2 (a). Many cracks and subsidences were seen on the upper parts of the slope.

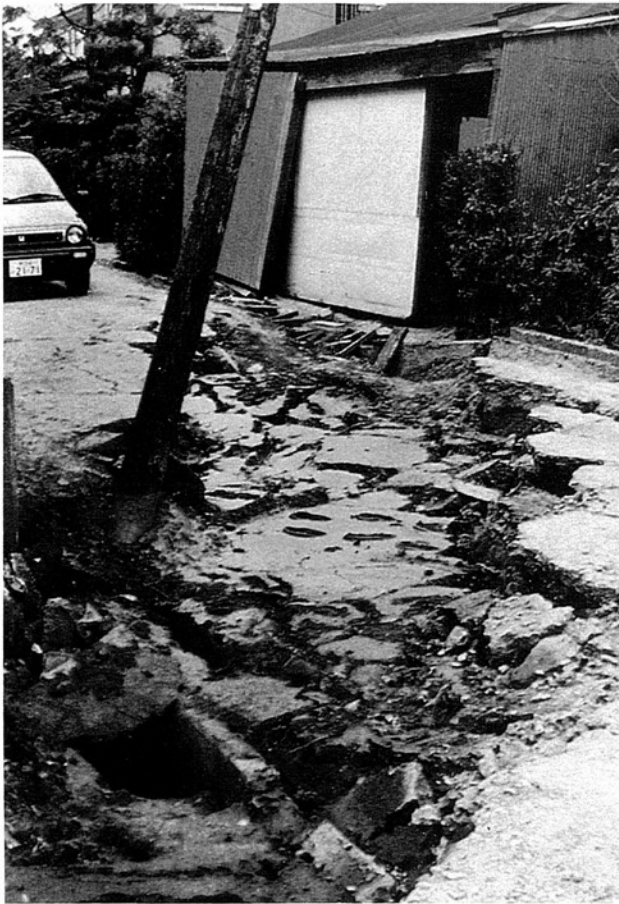
Photo 2-3 Cracks with subsidence on road in Aoba-cho (Courtesy of the Noshiro City Government)

Photos 2-3 and 2-4 show wide cracks and subsidences on a road, and a tree split by the ground

displacement in Aoba-cho. The locations and the directions of the two photographs are shown in Figure 2-5 along with the horizontal vectors of the permanent ground displacements in the surrounding areas. Sand volcanoes were found around the split tree.

tensile strain of 1.7% was calculated in the vicinity of the cracks and the split tree. It is noteworthy that the direction of the tensile strain coincides with those of the splitting of the tree and the ground cracks.

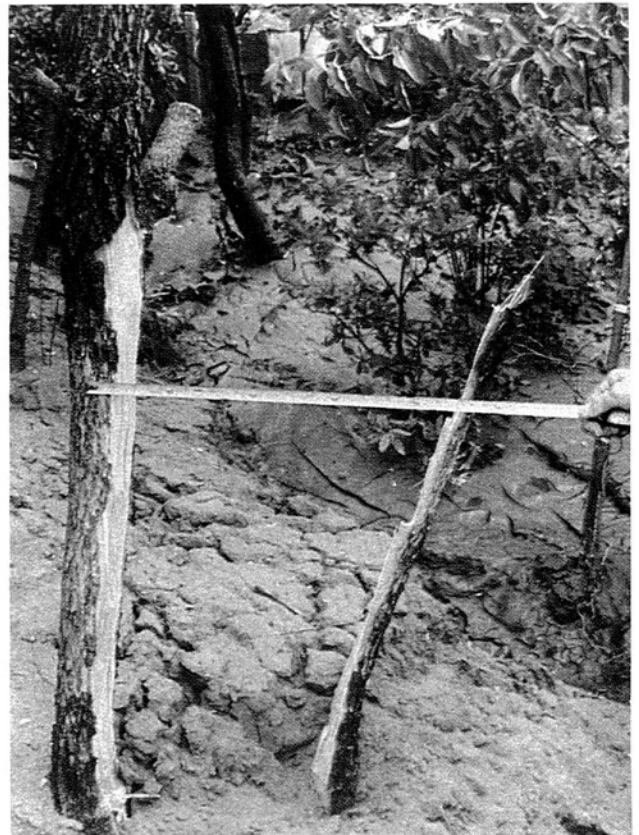
Photo 2-4 A vertically split tree due to liquefaction in Aoba-cho (Courtesy of the Noshiro City Government)

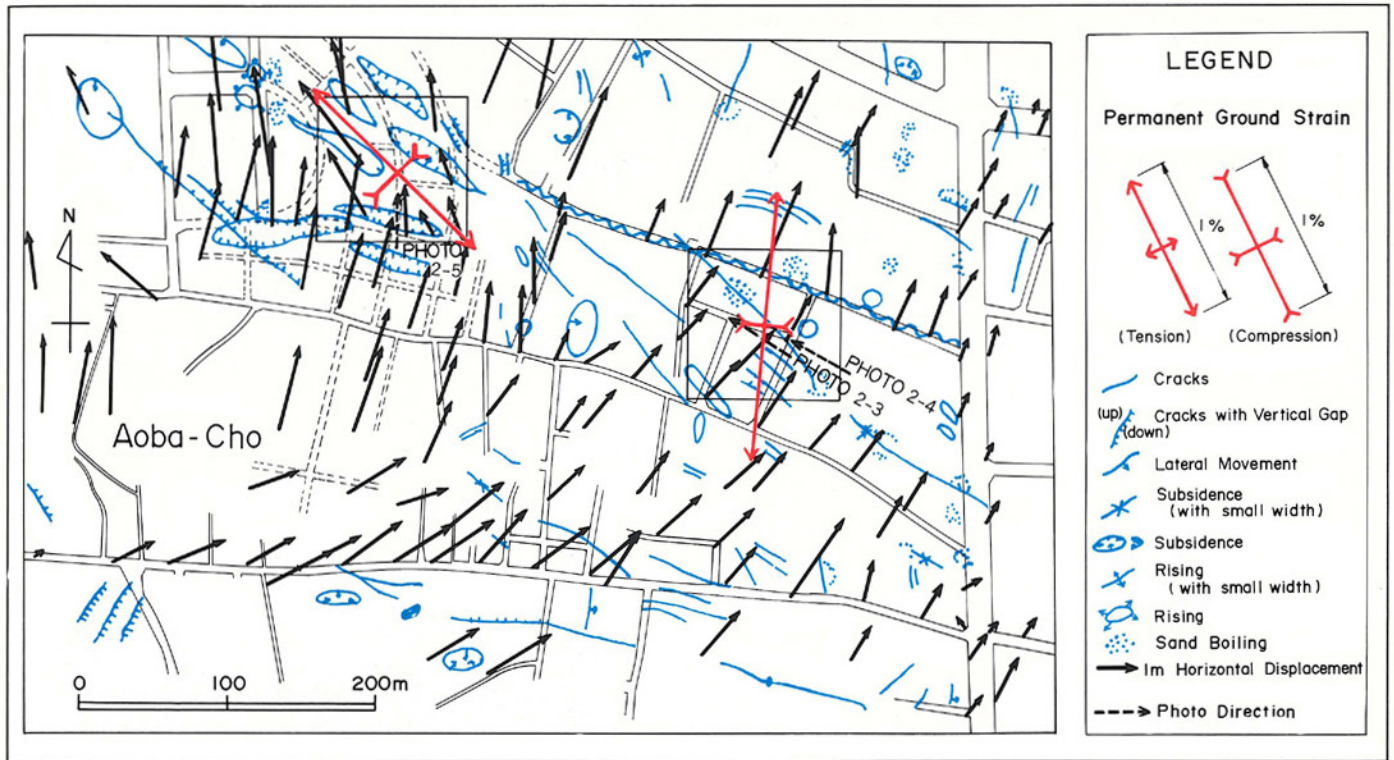
Fig. 2-5 Locations of photos 2-3, 2-4, and 2-5, and horizontal displacements in the surrounding area in Aoba-cho

Figure 2-5 also shows the permanent ground strains calculated from the measured displacements by a method to be outlined in Chapter 5. A large

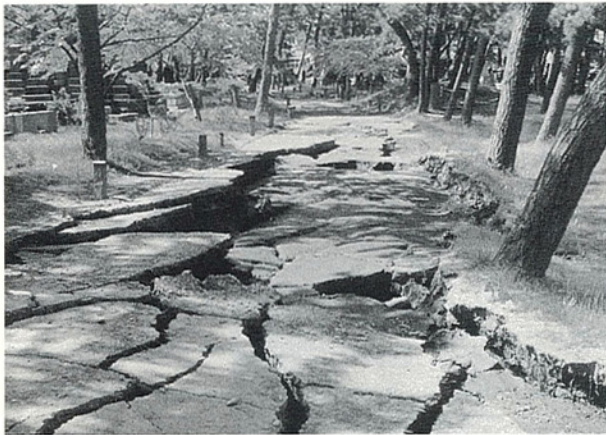
Photo 2-5 Cracks in the road leading to the graveyard in Aoba-cho (Courtesy of the Noshiro City Government)

Photo 2-5 shows another example of a ground failure, in the graveyard in Aoba-cho, where the permanent ground displacement was 1.5 to 2.5 m and the tensile strain of the ground, 1.5%, as shown in Figure 2-5.

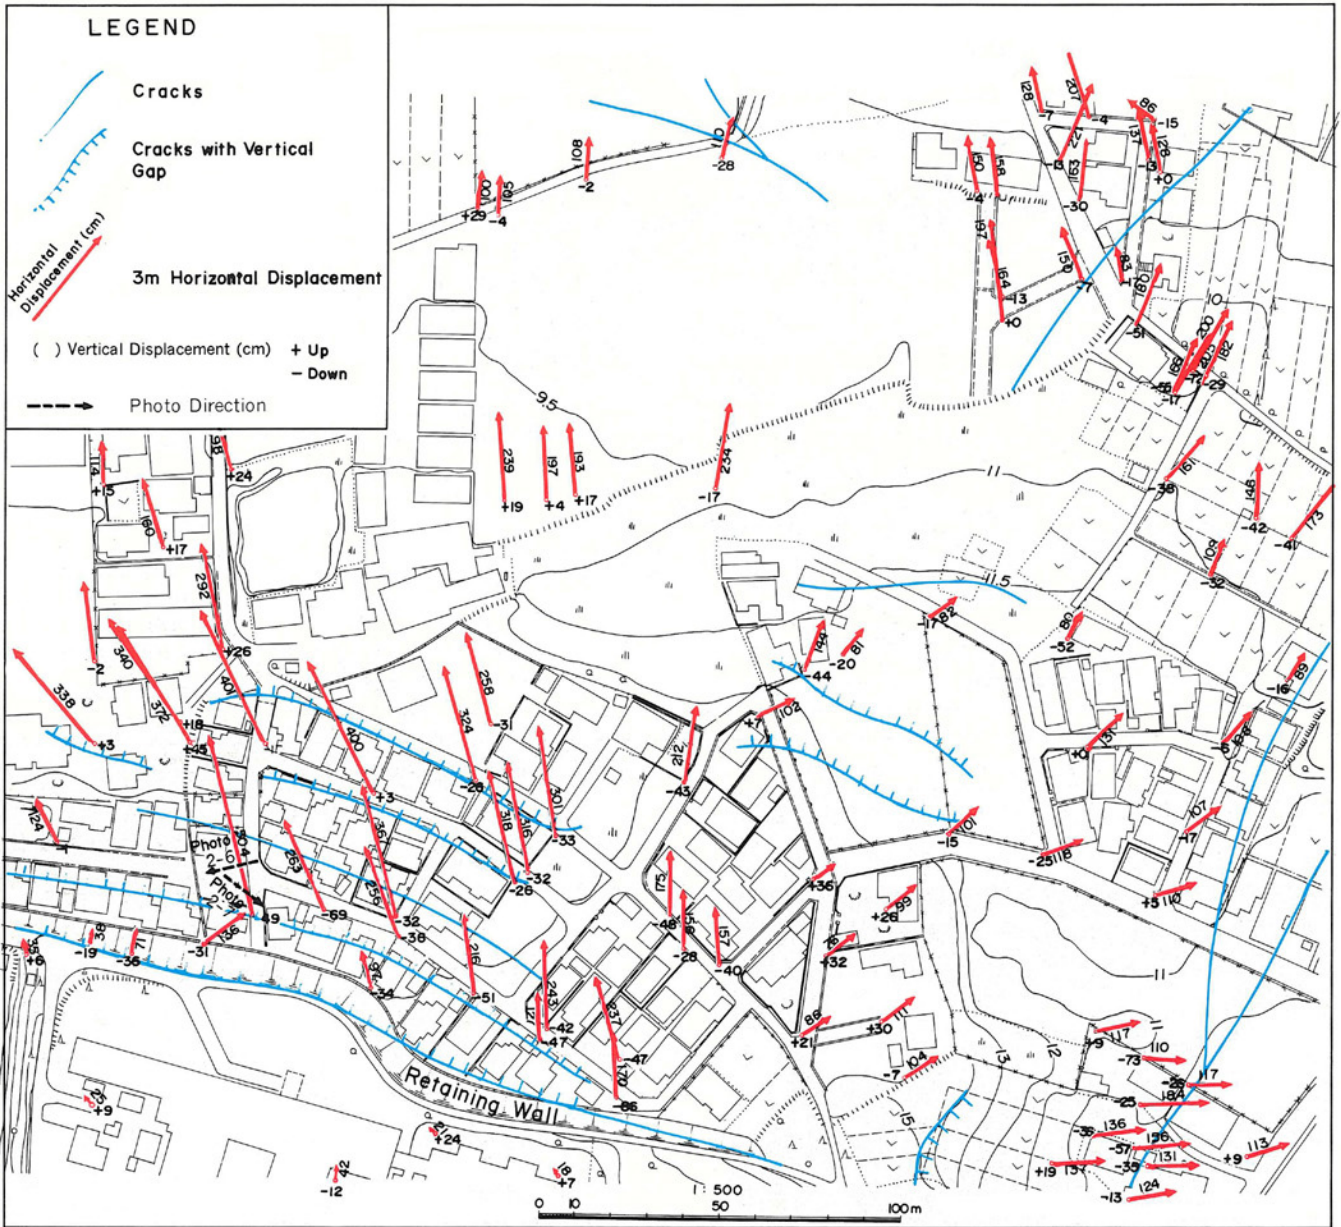
Fig. 2-6 Locations of photos 2-6 and 2-7, and the horizontal displacements on the northern slope of Mae Hill

Figure 2-6 also shows the vertical displacements subsidence and rising of the ground surface.* It shows that the ground subsided near the top of the sand dune, while the ground heaved at the bottom of the slope. The maximum subsidence was about 90 cm below the retaining wall near the top.

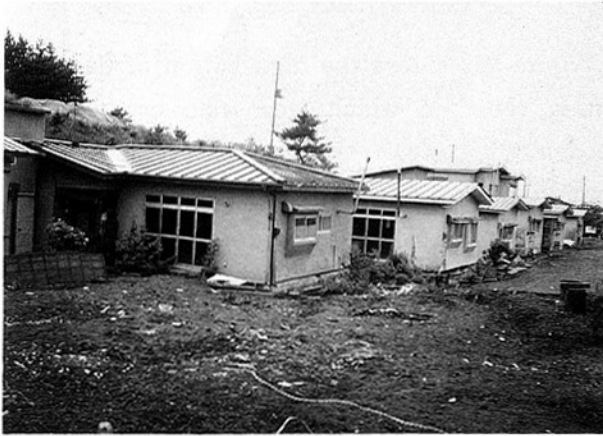
Photo 2-6 Undulating ground on the northern slope of Mae Hill
(Courtesy of Prof. Y. Mori, Nihon Univ.)

Photos 2-6 and 2-7 show some examples of ground failures on the northern slope of Mae Hill. The locations and the directions of photographs are shown in Figure 2-6. From Photo 2-6, which was taken in a northeasterly direction toward Mae Hill, it can be seen that the ground surface was undulated. Most of the houses in this area were severely damaged, making them uninhabitable. Photo 2-7 shows one example of the cracks found in this area with subsidences which ran parallel to the retaining wall, shown in Figure 2-6.

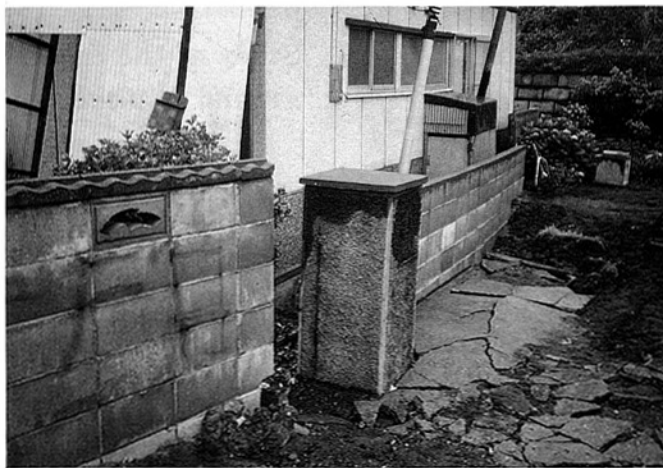
Photo 2-7 Cracks with subsidence on the northern slope of Mae Hill
(Courtesy of Prof. Y. Mori, Nihon Univ.)

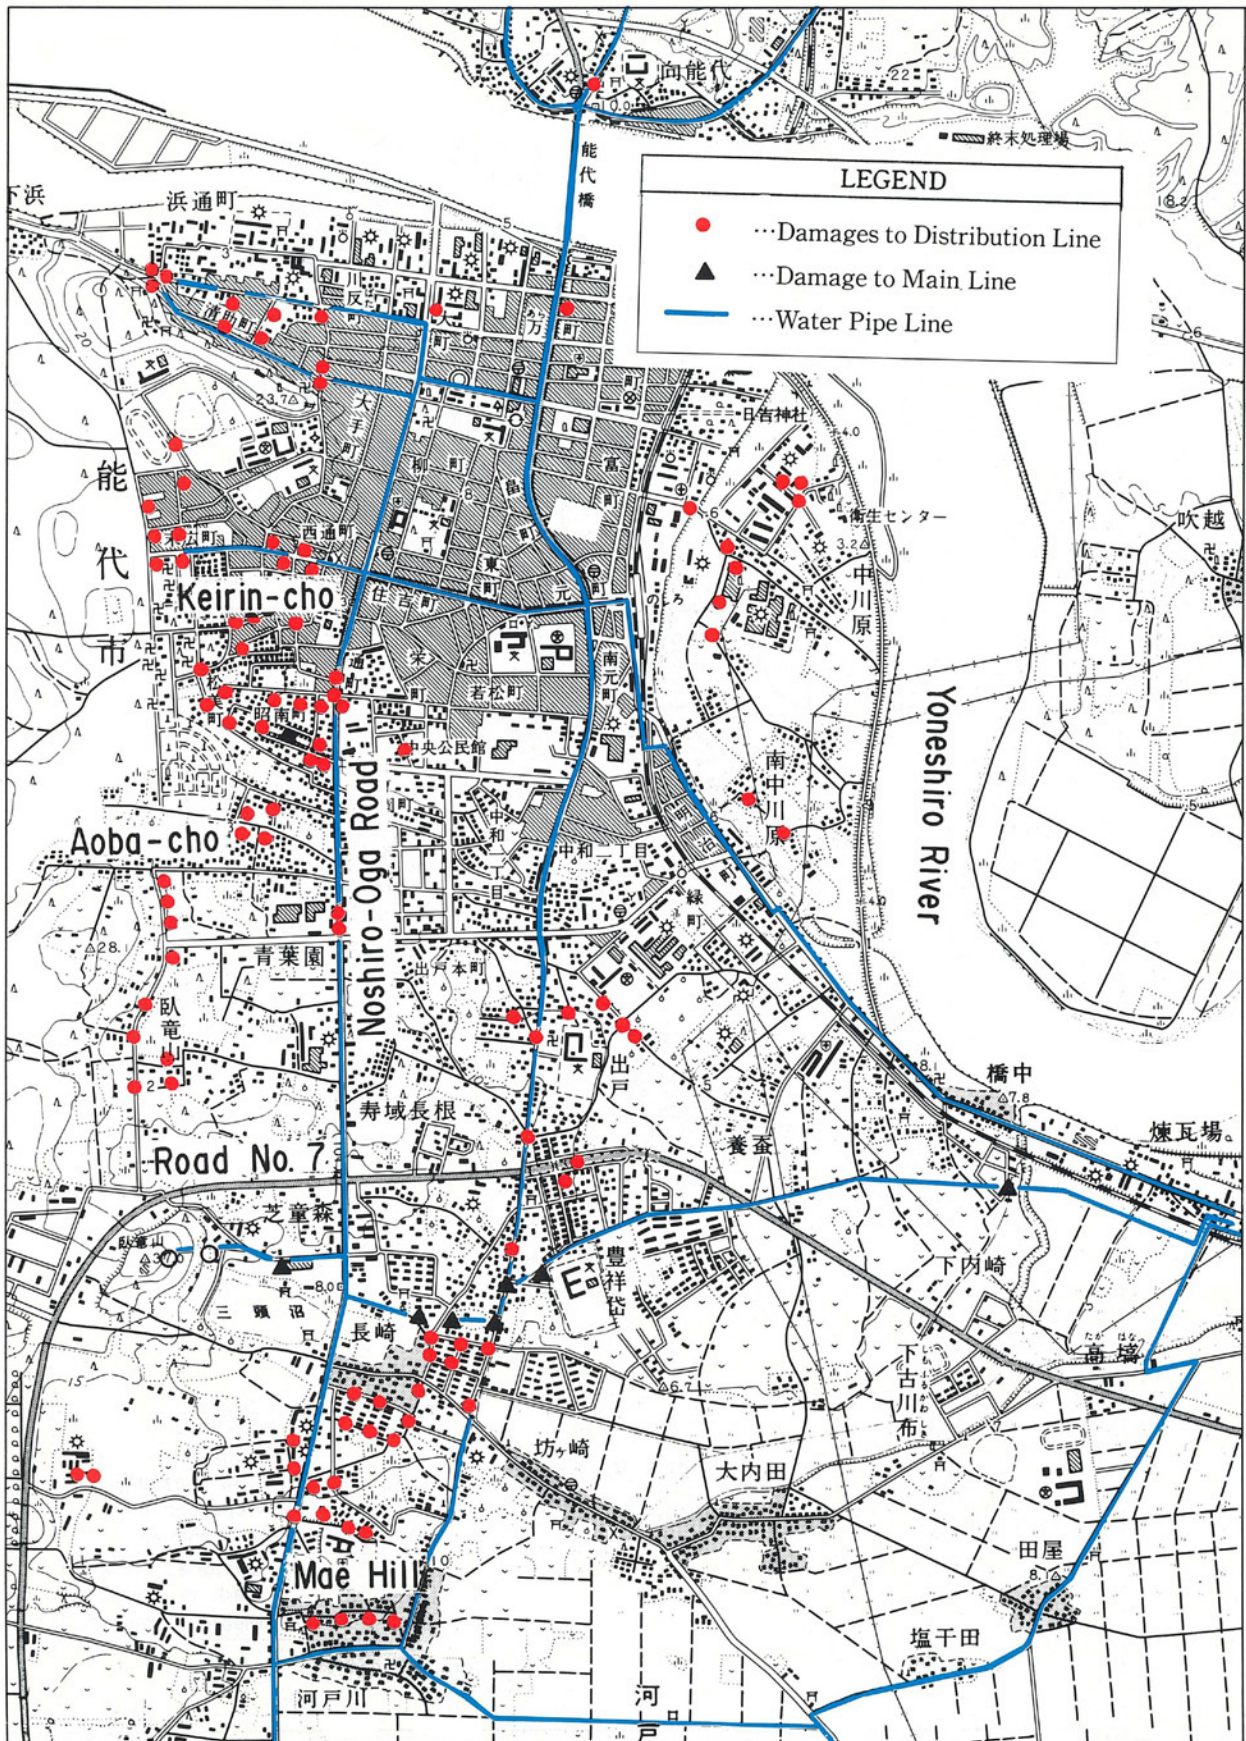
Fig. 2-7 Distribution of damage to buried water pipes in Noshiro City (Courtesy of the Noshiro City Government)

Figure 2-7 shows the distribution of damage to water pipelines in Noshiro City. The pipelines consist of cast iron pipes, asbestos-cement pipes, polyvinylchloride pipes, and concrete pipes with diameters ranging from 50 to 450 mm. The water supply pipes were distributed throughout all areas of the urban district, but the damage to them was mainly concentrated in the areas where the permanent ground displacements were large. Most of the damage to water pipes was caused in the area between Aoba-cho and Keirin-cho in the northern part of the city, as well as in the area between Mae Hill and Road No. 7 in the southern part. However, very little damage was found in the area east of Noshiro-Oga Road.

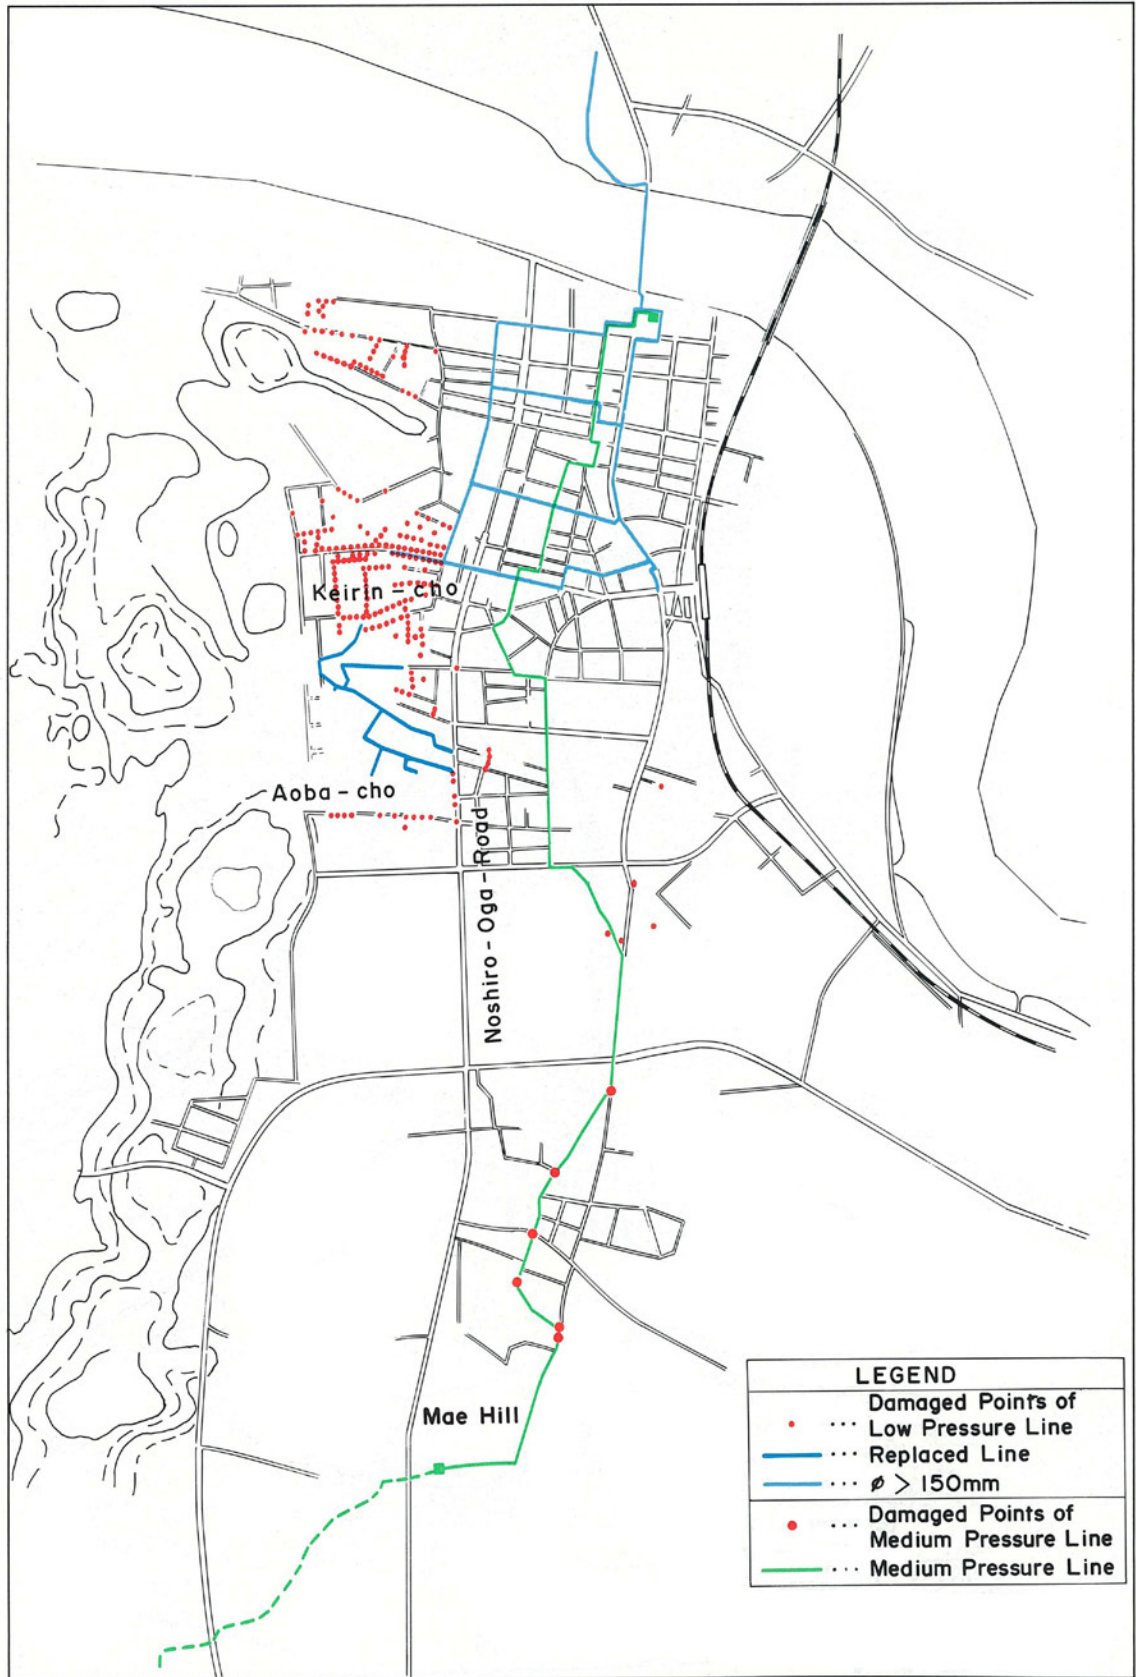
Fig. 2-8 Distribution of damage to buried gas pipes in Noshiro City (Courtesy of the Noshiro City Government)

Figure 2-8 shows the distribution of damage to gas pipes, which include both low and medium pressure lines. The low pressure lines consist of screw jointed cast iron pipes and polyvinylchloride pipes, which were installed only in the northern part of the city. The medium pressure lines consist of 80 mm diameter arc-welded steel pipes.

The distribution of the damage to the low pressure lines is similar to that of the damage to the

water supply pipes. The damage was much more severe in the area west of the Noshiro-Oga Road, Aoba-cho, Keirin-cho, etc. On the east side of the road, little damage was found to the buried gas pipes.

The medium pressure lines were damaged in the southern part of the city. The failure process of the medium pressure gas pipe will be investigated by numerical analyses in Chapter 6.

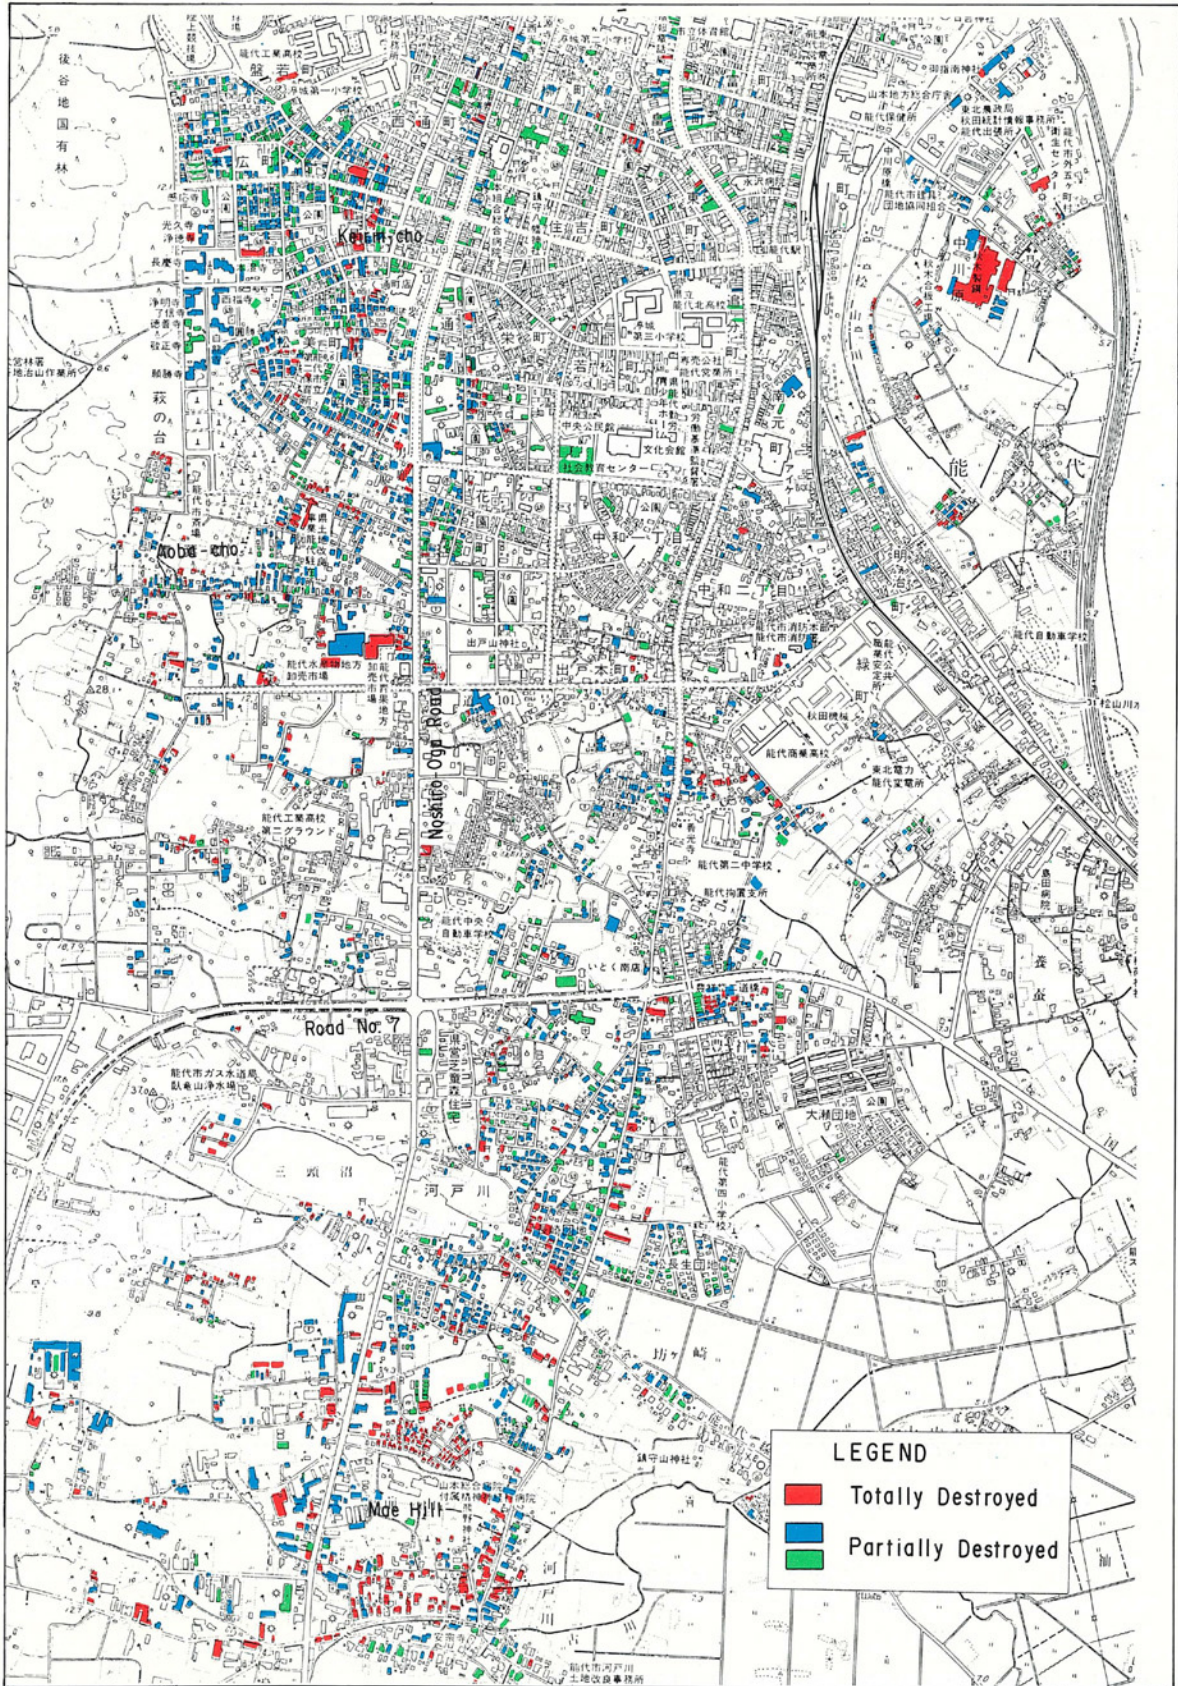
Fig. 2-9 Distribution of damage to houses in Noshiro City (Courtesy of the Noshiro City Government)

Figure 2-9 shows the distribution of damage to houses, most of which were one or two-storied wooden structures. It was reported⁽⁹⁾ that the damage to houses was caused mainly by nonuniform subsidences, cracks, and bulging of the foundation ground. The distribution of damage to houses mostly coincides with that of the permanent ground displacements.

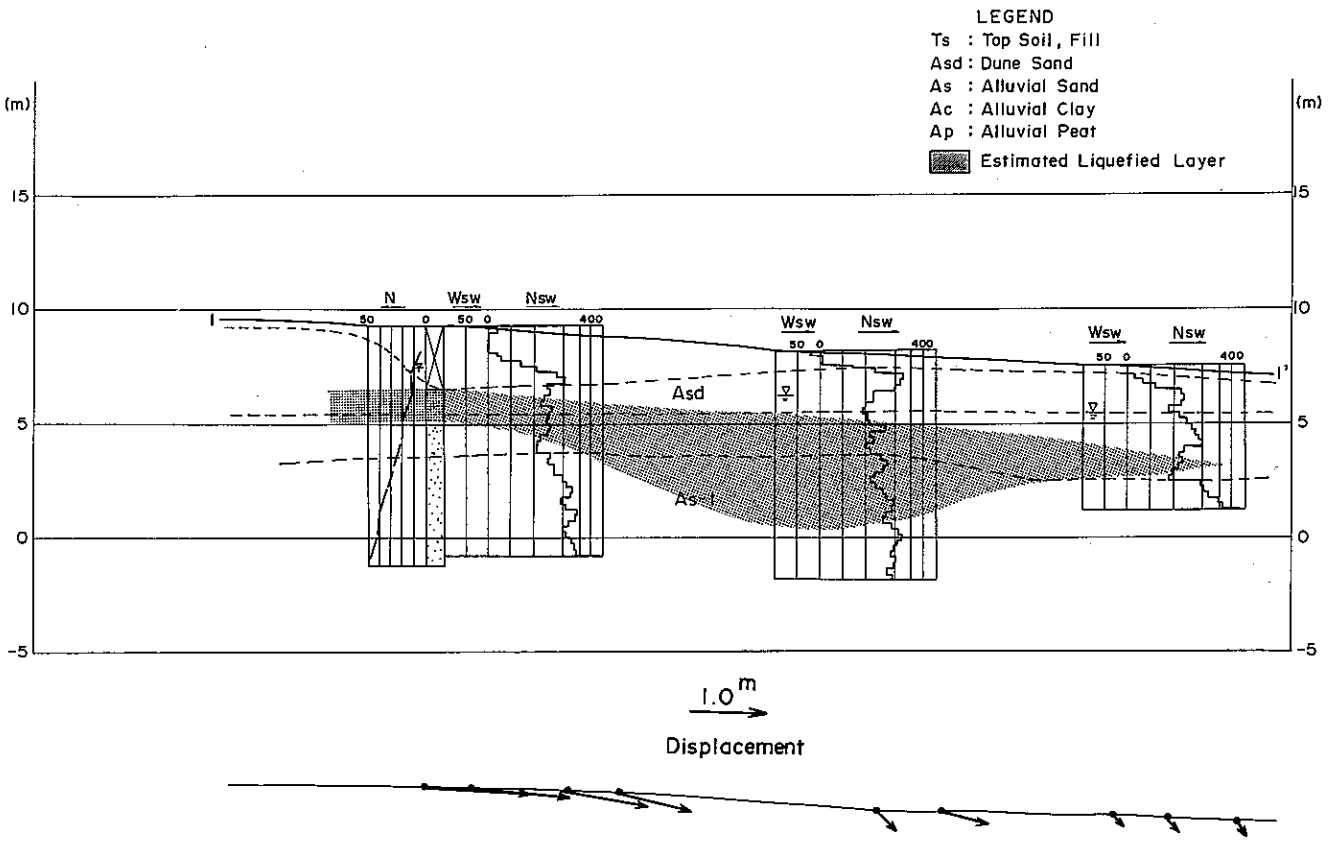
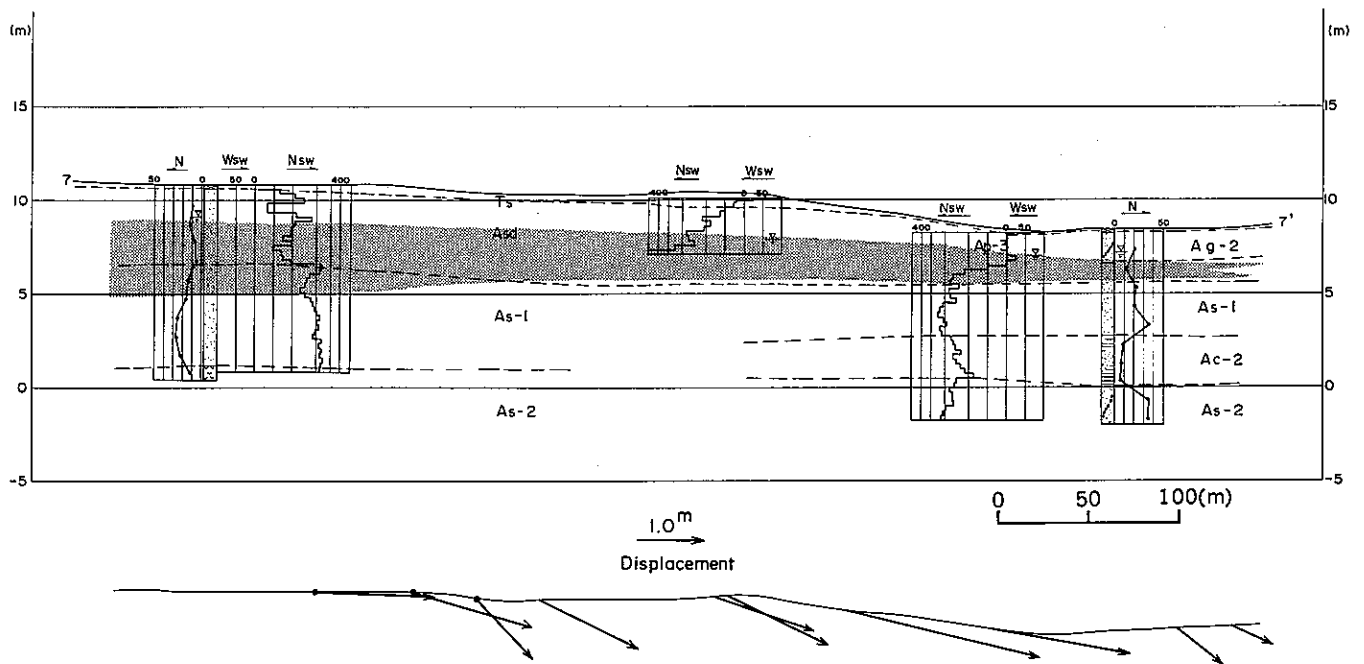
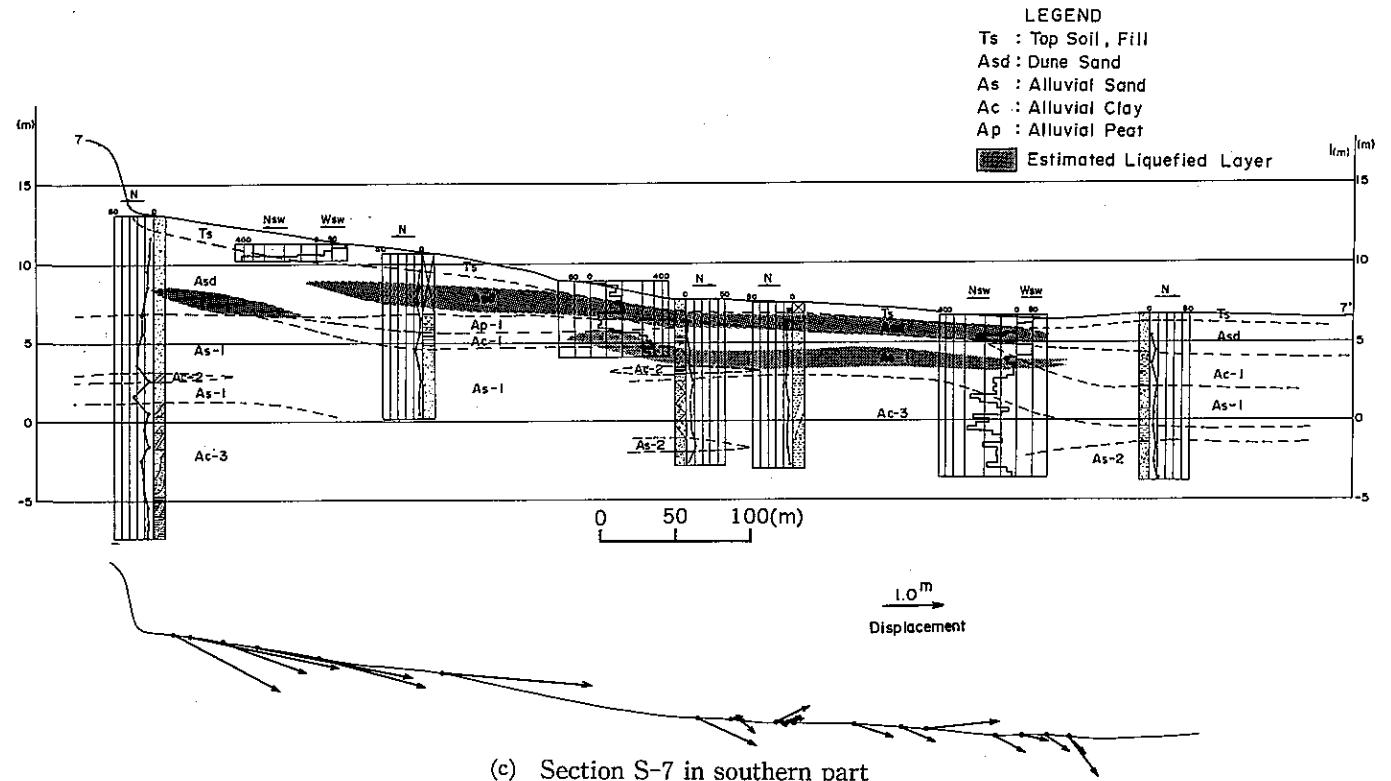
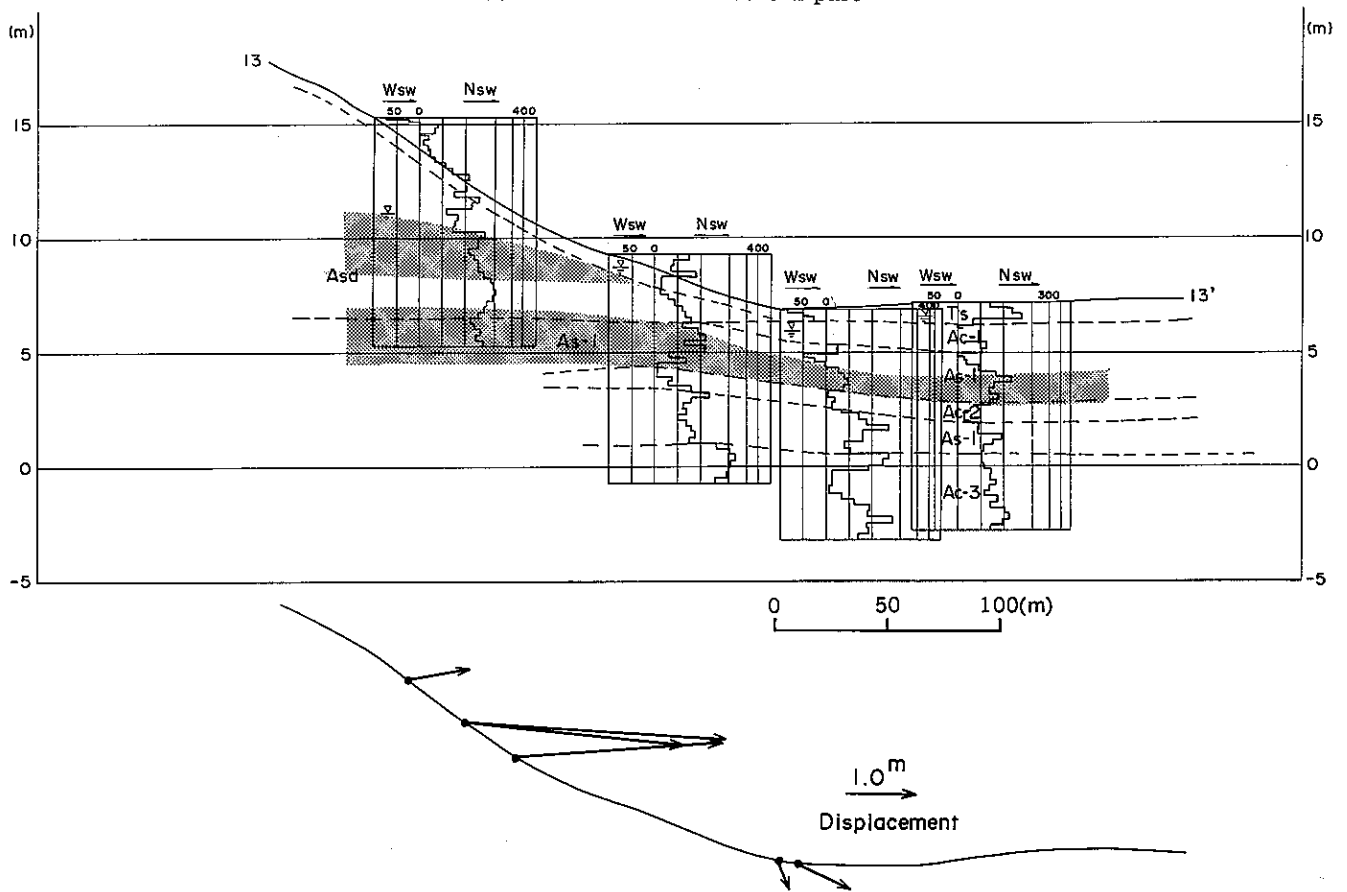
Fig. 2-11 Soil layer profiles and estimated liquefied layers

Figure 2-11 shows four examples of soil layer profiles and the estimated liquefaction zones, together with the permanent ground displacement vectors along each section. The horizontal displacements shown in the figure are the components of the displacement vectors in the direction of the section.

The liquefaction layers along sections S-7 and S-13 in the southern area are a little complicated, consisting of two or three layers, because silty layers, which have a higher resistance against liquefaction, exist between the sandy layers. However, along all sections, * liquefied soil layers with a thickness of 2 to 5 m underlie the gently sloped ground surfaces which have gradients of less than 6%. Hence, it can be easily concluded that the soil liquefaction was mainly responsible for the permanent displacements on the slope.

Generally speaking, the magnitude of the permanent ground displacement is larger where the liquefied soil layer is thick and the gradient of the slope is large. As shown by the soil profile and the liquefaction layer along the sections, the permanent ground displacements become much smaller near the toe of the slope where the liquefied layers become thinner and the ground surface is flat. Therefore, the gradient of the ground surface and the thickness of the liquefied layer can be considered as the influential factors for the magnitude of the displacement. A quantitative analysis of these factors will be done in Chapter 4.
