### 3 . Permanent Ground Displacements in Niigata City during The 1964 Niigata Earthquake

It was reported that liquefaction occurred mostly in reclaimed former channels of the Shinano and Tsusen Rivers in Niigata City<sup>(1)</sup>

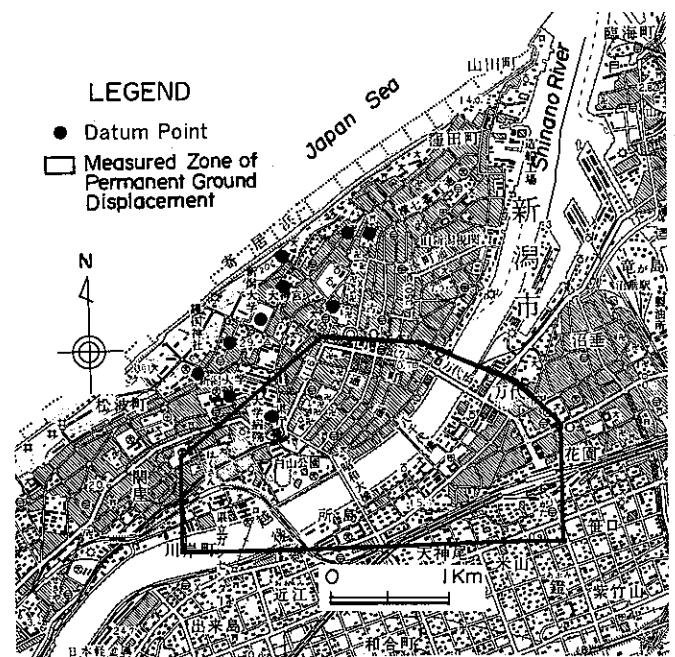
Fig. 3-1 Measured area and datum points for aerial survey

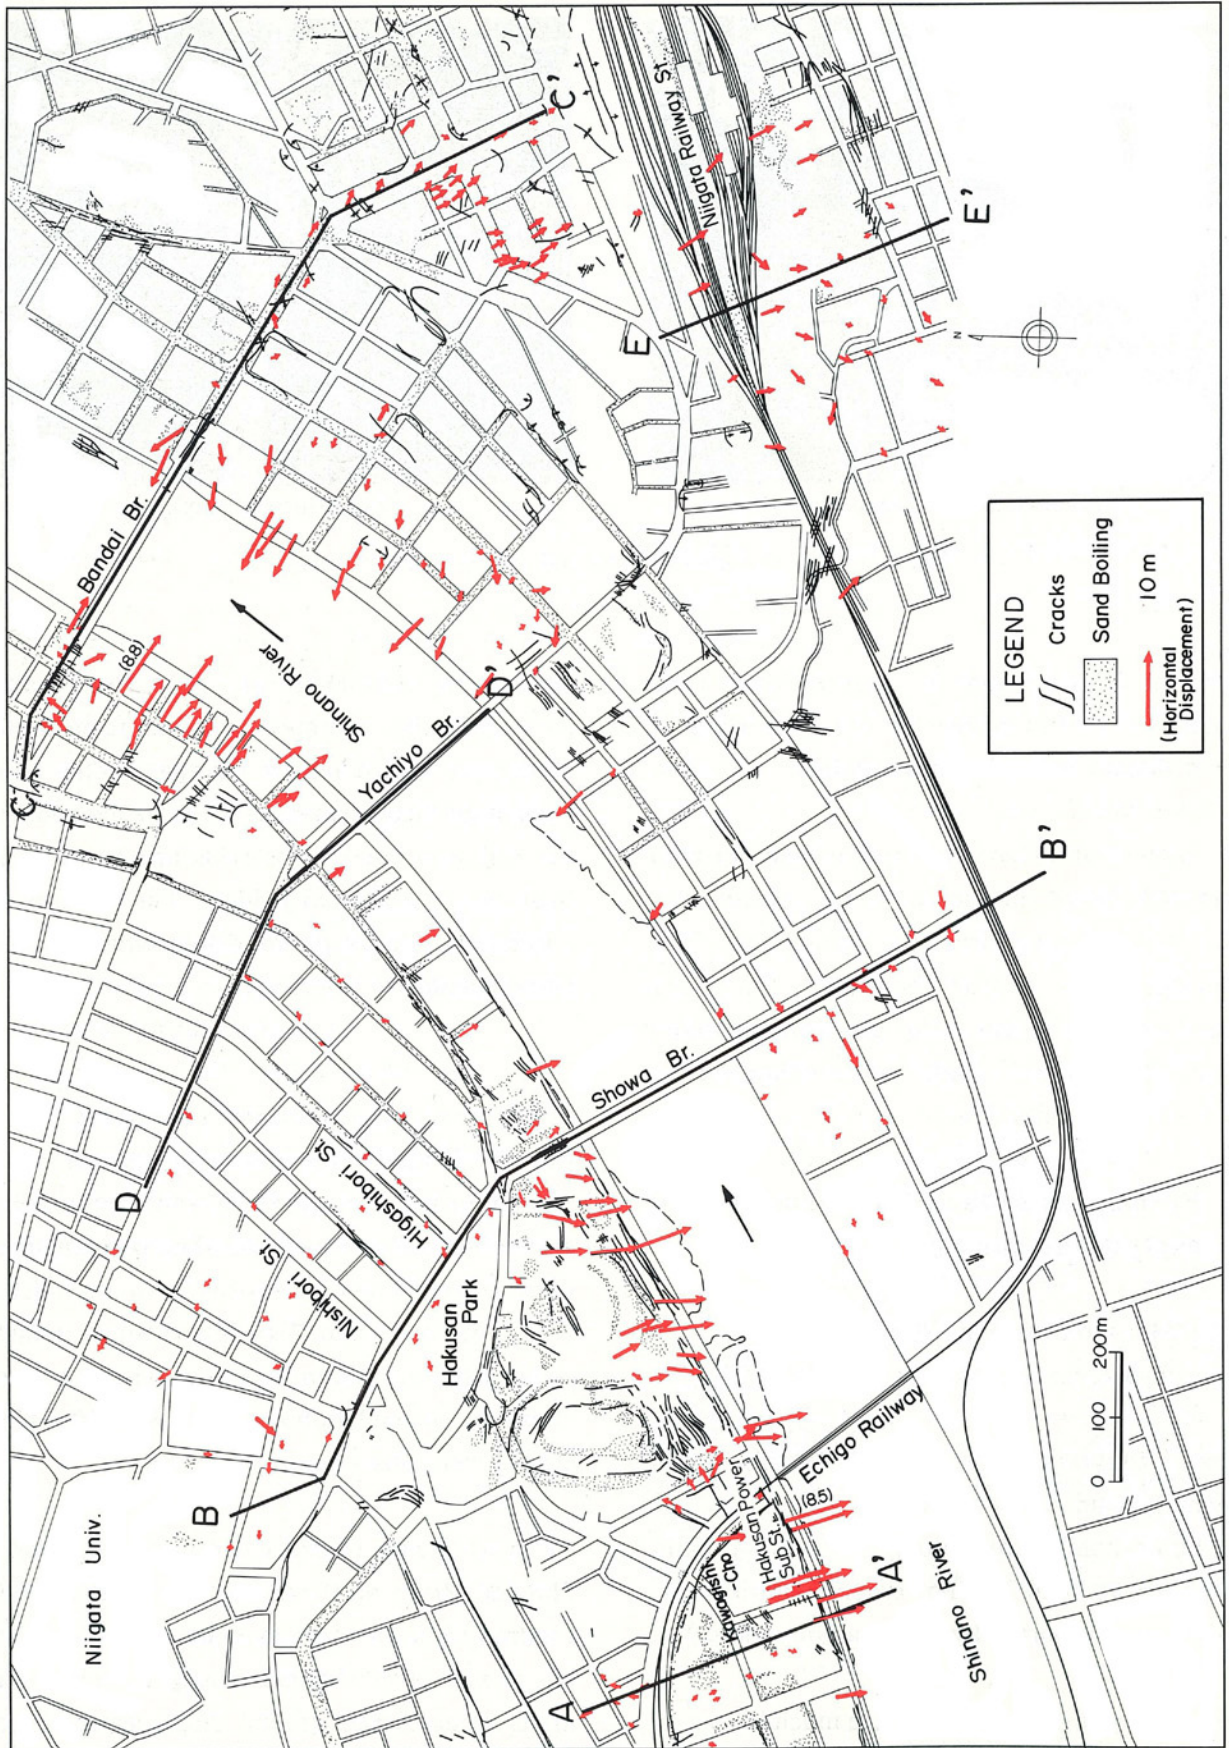
Fig. 3-2 Permanent horizontal ground displacements in Niigata City during the 1964 Niigata earthquake

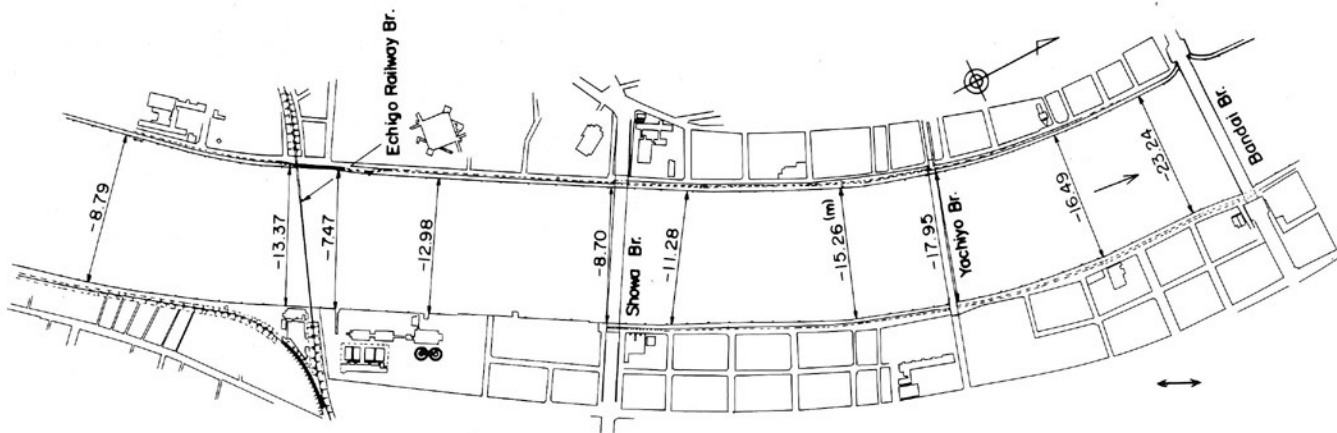
Fig. 3-4 Reduction of river width during the Niigata earthquake (m)

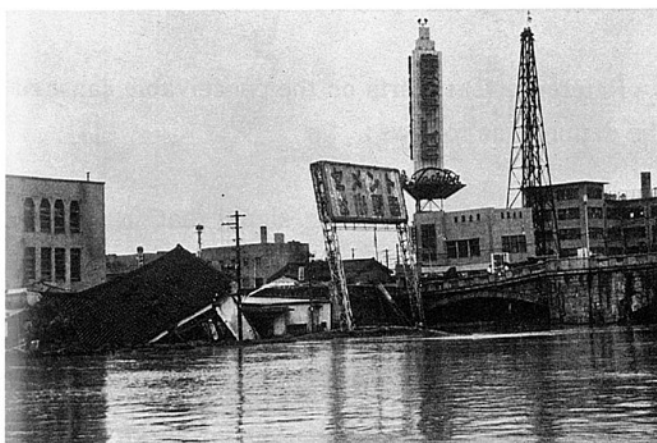
Photo 3-4 Displacement of a building toward the river on the left bank near Bandai Bridge

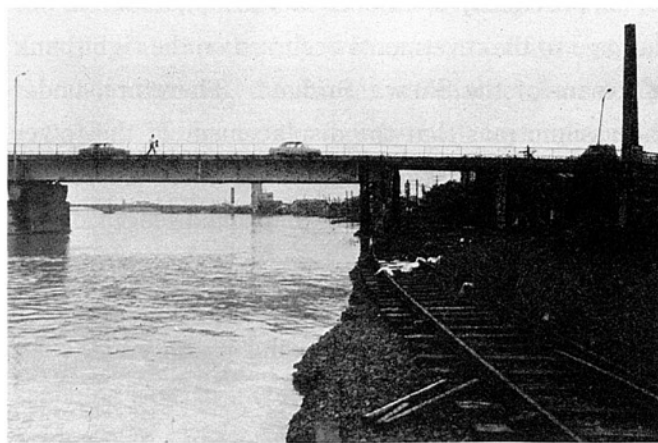
Photo 3-5 Horizontal displacements of right bank near Yachiyo Bridge

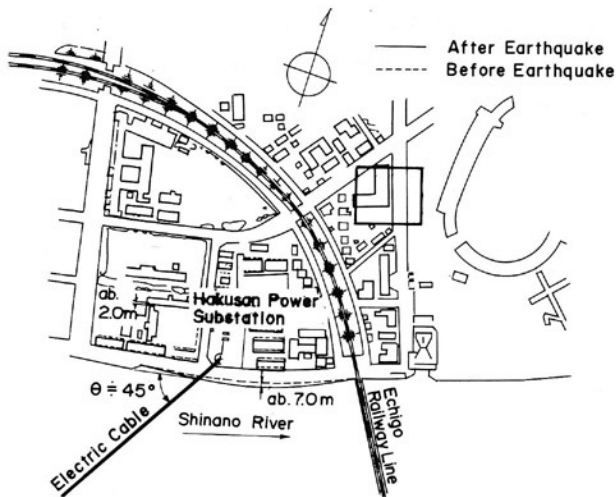
Fig. 3-5 Displacements of Hakusan power substation<sup>(1)</sup>

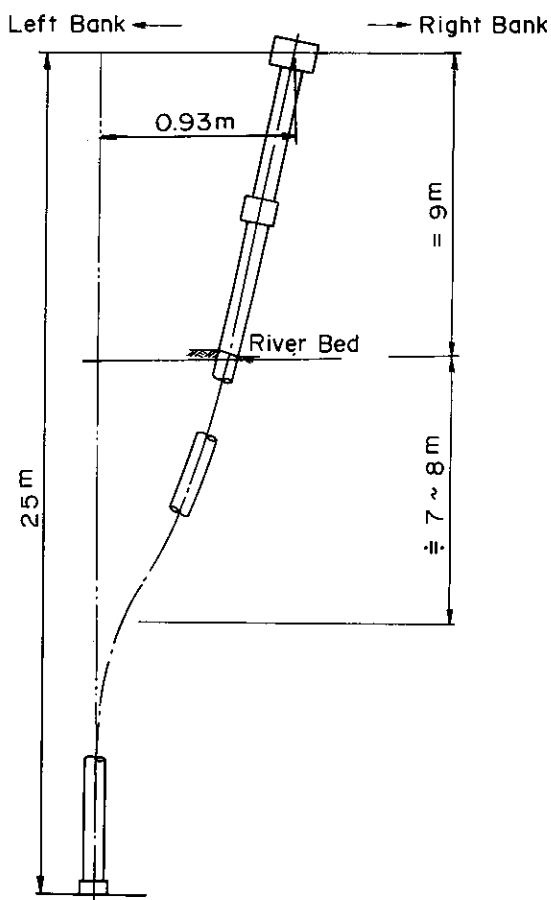
Fig. 3-7 Damage to steel pipe piles of pier P<sub>4</sub> of Showa Bridge<sup>(1)</sup>

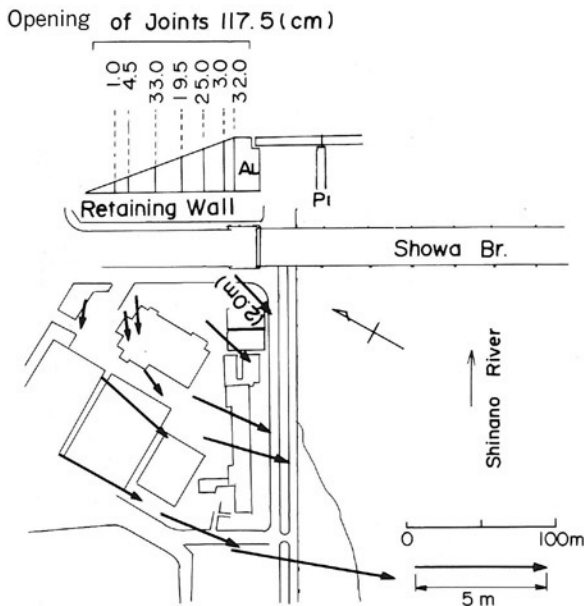
Fig. 3-8 Damage to retaining wall of access road of Showa Bridge<sup>(1)</sup>

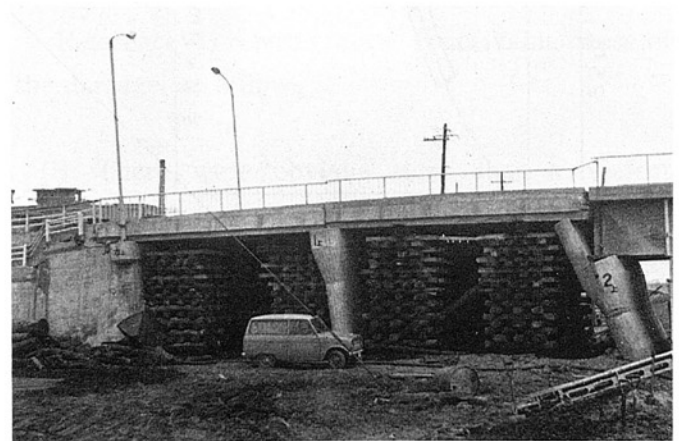
Photo 3-7 Damage to the abutment and the piers of Yachiyo Bridge on the left bank

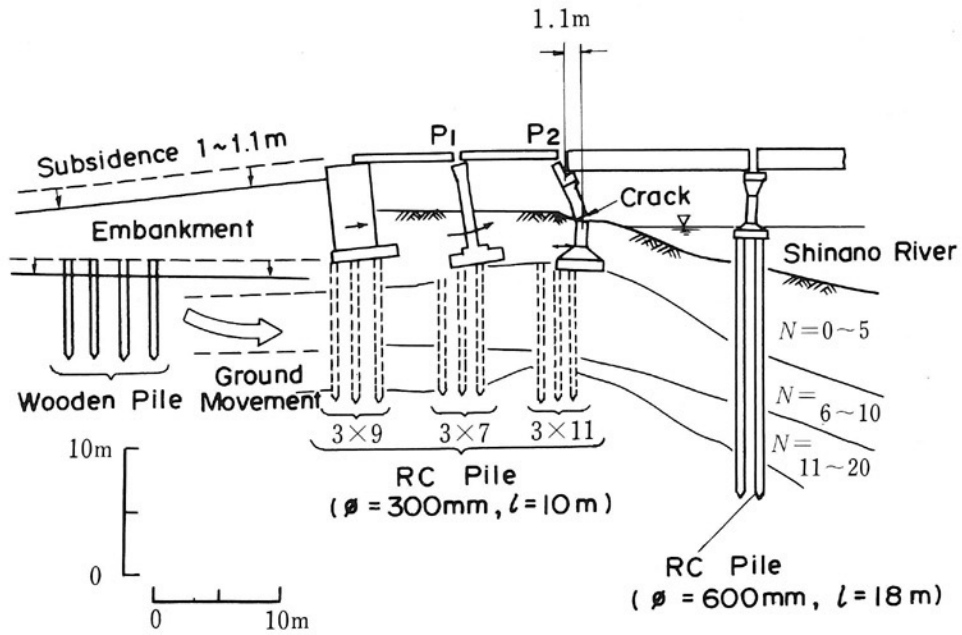
Fig. 3-9 Damage to the abutment and the piers of Yachiyo Bridge on the left bank<sup>(11)</sup>

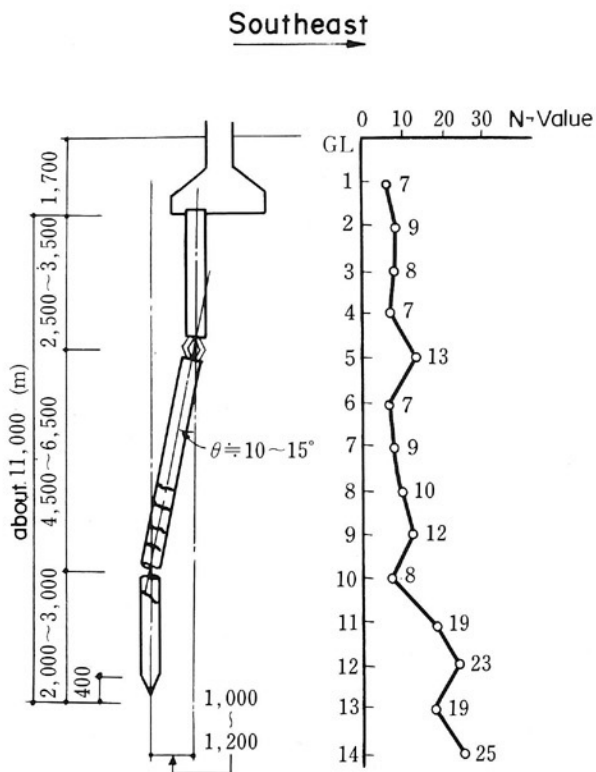
Fig. 3-10 Broken RC pile and soil condition<sup>(12)</sup>

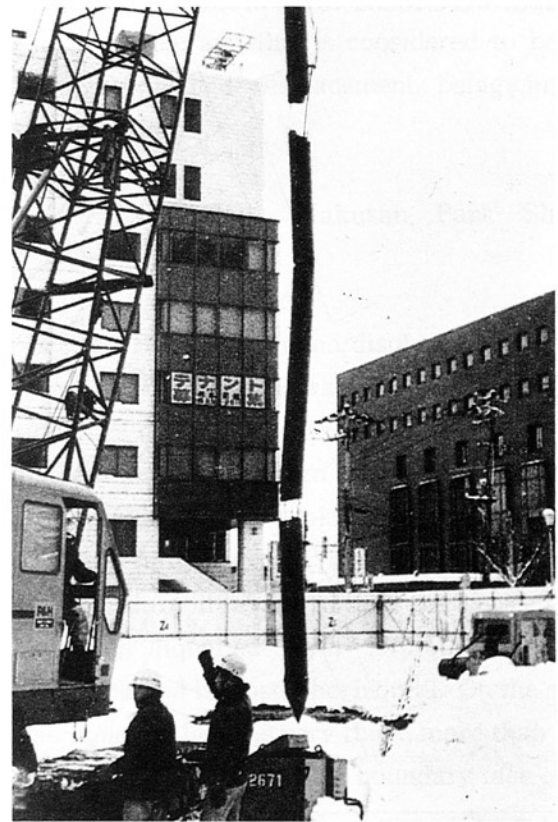
Photo 3-8 Damage to RC pile  
(Courtesy of Dr. S. Kawamura, et al.)

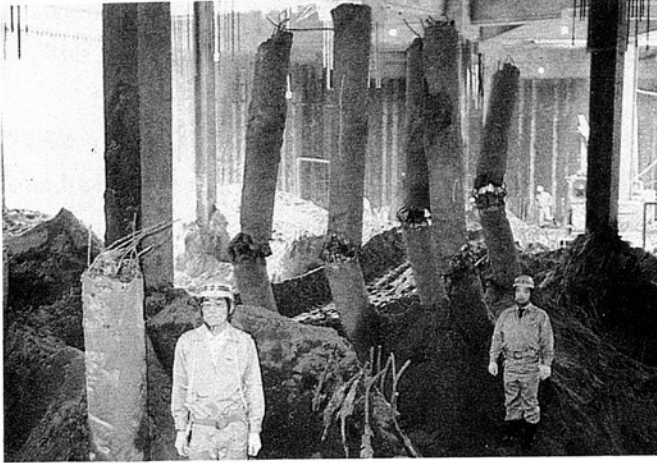
Photo 3-9 Damage to RC pile  
(Courtesy of Dr. S. Kawamura, et al.)

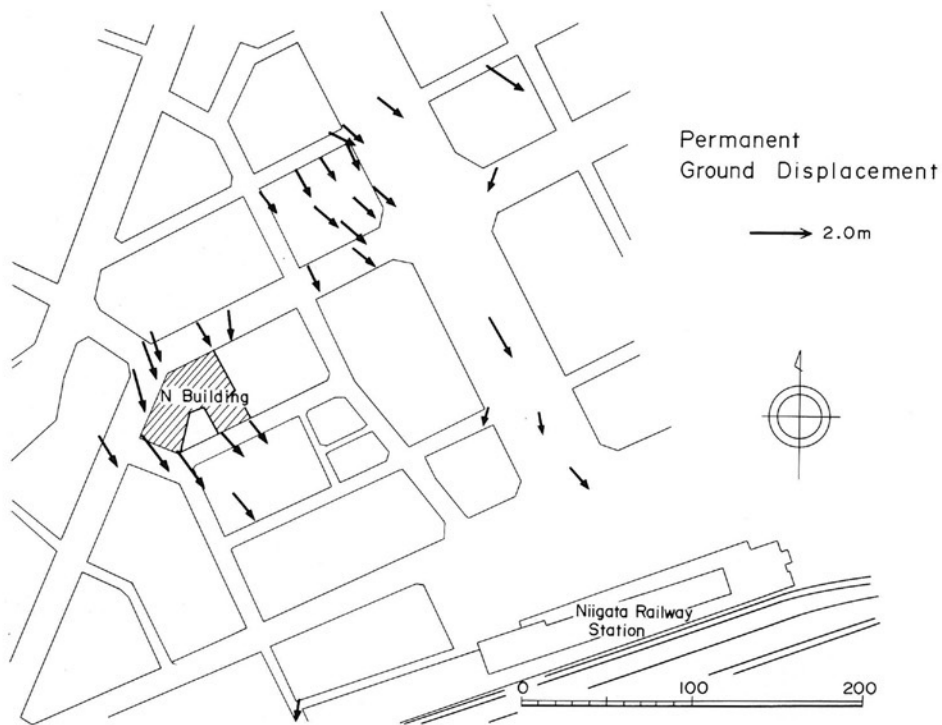
Fig. 3-11 Permanent ground displacements near the building where RC piles were damaged

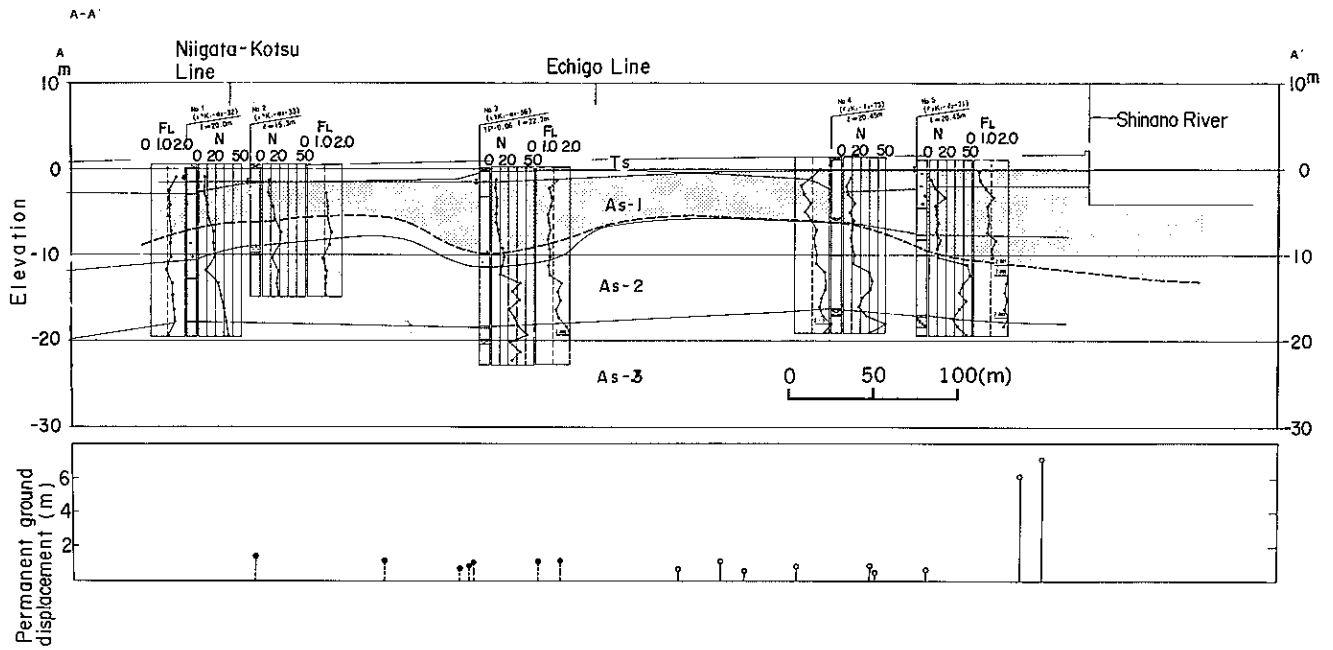
As previously mentioned, in the areas near Higashibori and Nishibori Streets, very small permanent ground displacements occurred, although sand boiling and cracks were observed. The streets were constructed by reclaiming the old canals around 1955. Although the detailed soil condition of the reclaimed ground is unknown, the results of standard penetration tests conducted near the street indicate that the liquefaction resistance is comparatively high. Consequently, it may be assumed that only the reclamation material of the street liquefied, without causing a permanent ground displacement.
