2 . Permanent Ground Displacements in Noshiro City during The 1983 Nihonkai-Chubu Earthquake

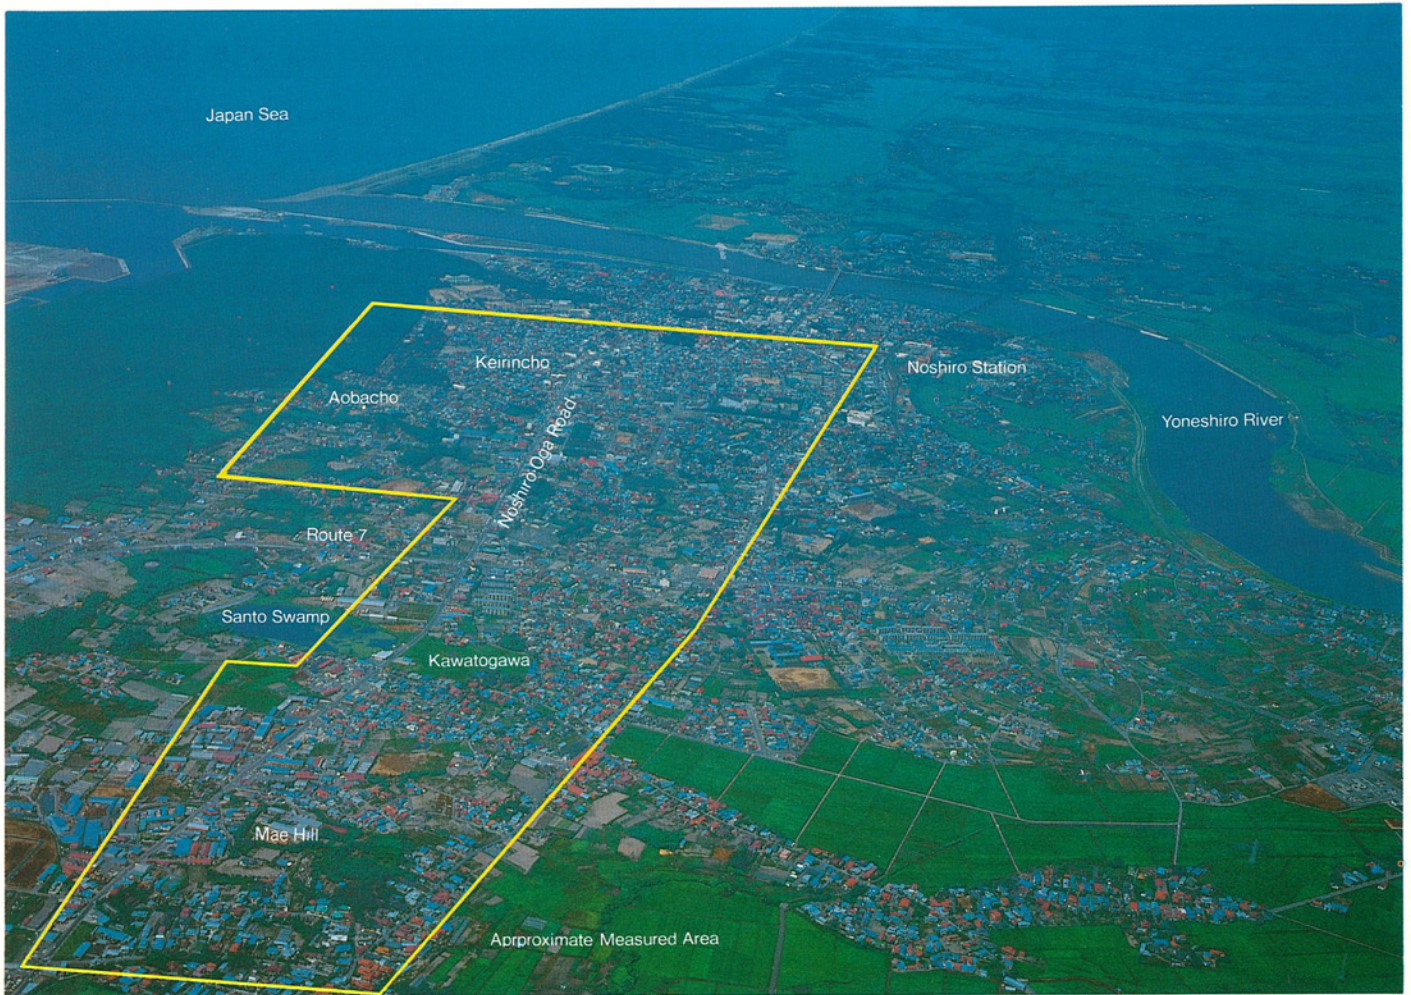
Photo 2-1 Bird's-eye view of Noshiro City and measured area (Courtesy of the Noshiro City Government)

Figure 2-2 and Photo 2-1 show the measured area of the permanent ground displacement in Noshiro City. The displacements were measured mainly in the areas where damage to houses and buried pipes and ground failures such as cracks and subsidences were observed.

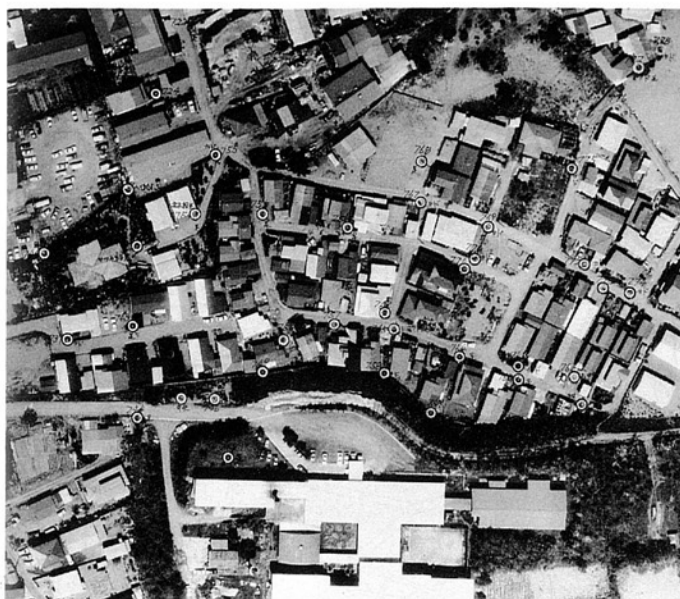
(a) Northern slope of the Mae Hill

In the southern part, as shown in Figure 2-4, large cracks and subsidences were found around Mae Hill, where displacements exceeding 5.0 m occurred. Details of the permanent ground displacements and ground failures on the northern slope of the hill are shown in Figure 2-6. The region shown in Figure 2-6 corresponds to Photo 2-2 (a). Many cracks and subsidences were seen on the upper parts of the slope.

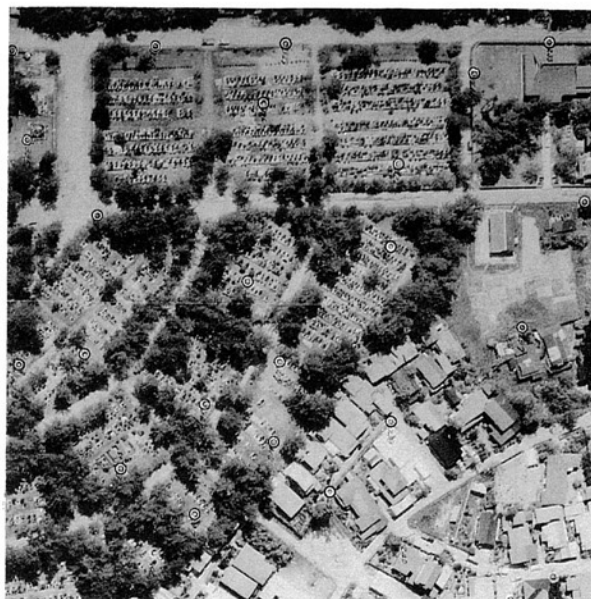
(b) Near a graveyard in Aoba-cho

fixed on the ground surface and which can be found in both the pre- and post-earthquake photographs. Manholes, cadastral boundary stones, bases of light poles, corners of drainage channels, etc., were preferentially selected, but in areas where measurement points such as these could not be found, the roofs of houses, which were confirmed not to have been damaged, were secondarily selected. A total of about 2,000 points was selected. Photo 2-2 shows examples of the aerial photographs and points of measurement on the northern side of Mae Hill and near the graveyard in Aoba-cho where the permanent ground displacements were dominant as shown in Figures 2-3 and 2-4.
